PRODUCT: Pink #4 Hard Top Valve

MFR: ST9 Gas & Oil

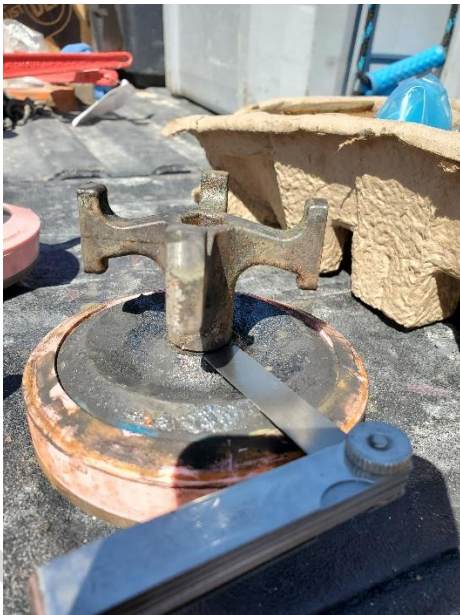
OBSERVATION: Gap between leg and body on pink #4 valve. Cracked threads on some valve bodies.

SOLUTION: On some of the inventory of pink #4 valves, the legs were not threaded completely into the valve body which caused leg breakage in some cases. Additionally, improper valve boss design along with faulty carburization process also led to cracked valve body. The solution was 2-part.

Pic 1: Leg gap

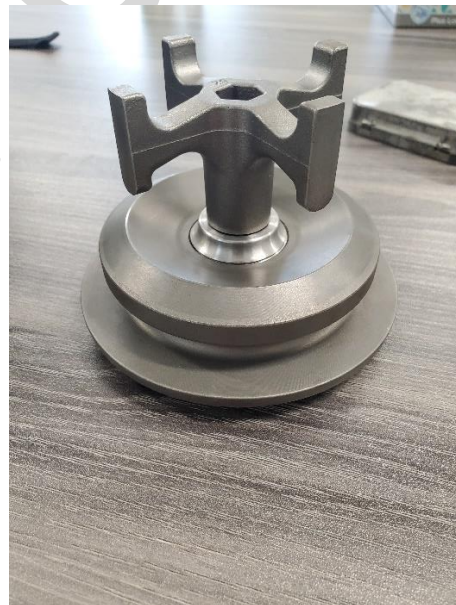
Pic 2: Insert fix for current inventory (w/o urethane)

Part 1: Current inventory was sent back to re-machine the thin boss and replace with an insert. This allowed us to circumvent the over-hardening of the threads during carburization. New legs were threaded into the valve body and torqued properly then sent to urethane. You may see some of these temporarily for the next several months. Functionally they are the same as the new valves shown in pic 3.

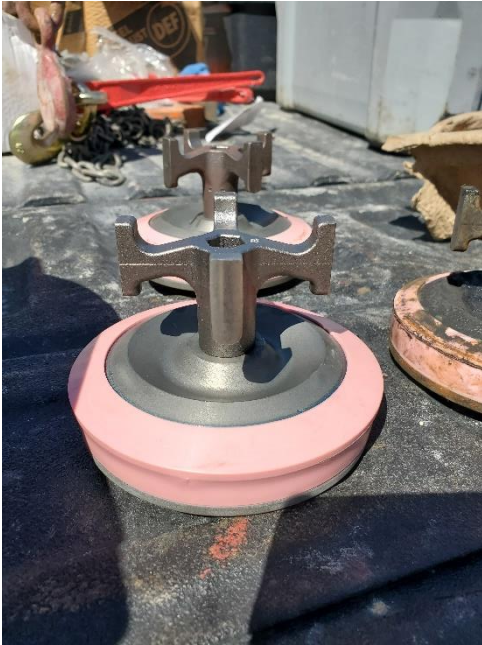
Pic 3: New valve

Part 2: For future inventory, the valve body undercut was modified to limit over-hardening of female valve body threads during carburization. The new valve is shown in picture 3.
