**PRODUCT:**

- 200-0073: Crank Lube Seal Housing Gasket
- 200-0063: Crank Lube Interior Seal Housing

**MFR:** ST9 Gas & Oil LLC

**MODIFICATION:**

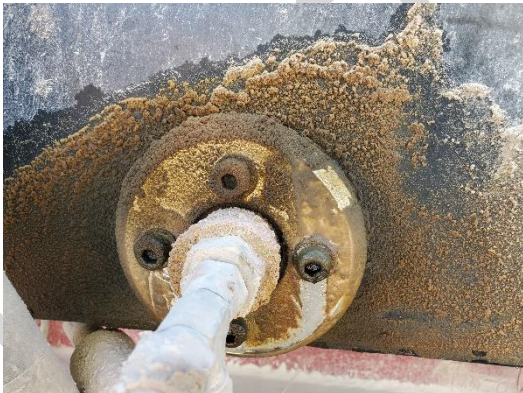
**Pic 1**

**DETAILS:** After several hundred hours of field use and sometimes on the test tank, there will be power end lube oil seepage from this gasket (Pic 1). LOS Odessa has been changing all the rubber gaskets to a cork/rubber mix before installing the power end onto a trailer which has greatly reduced the amount of leakage through these gaskets. Future power ends from ST9 will come standard with these cork/rubber gaskets already installed (Pic 2).

**Leaking gasket (common on many field PE)**

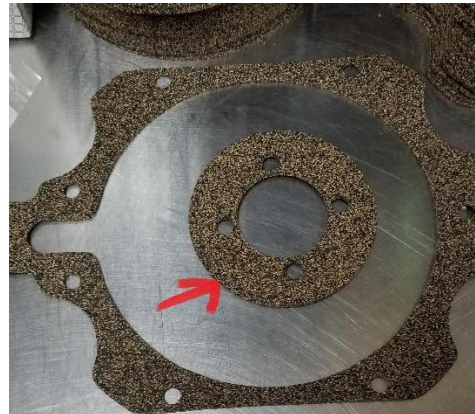
**Pic 2**

**200-0073 formerly pure rubber, now cork/rubber**
