PRODUCT:

- 250-0010: ST9 2500Q Power End
- 200-0038: Legacy left cover
- 200-0025: Legacy right cover
- 200-0291: New left cover with inspection port
- 200-0290: New right cover with inspection port

OVERVIEW:

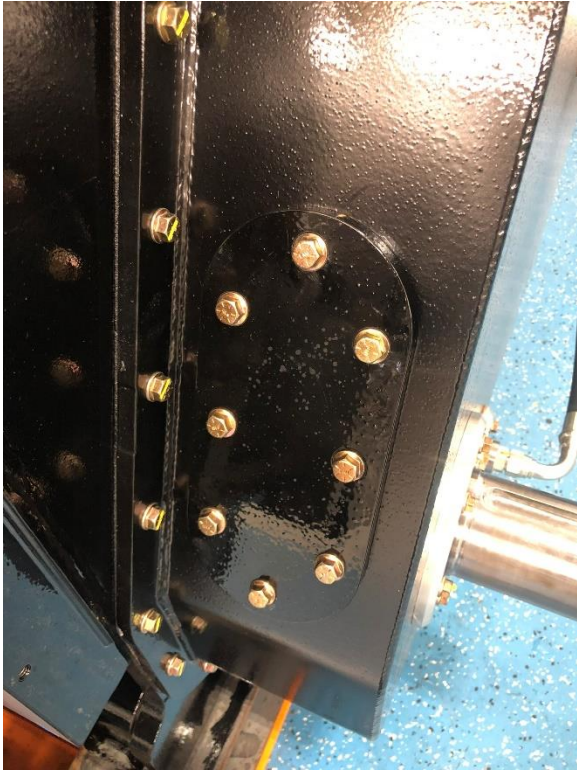
Installed and finished pictures show on the next page. Fig 1 shows the bottom cover fully installed. Fig 2 shows the top cover exposed revealing the bull gear bolt. Fig 3 displays the bull & pinion gear mesh. Fig 4 shows the top cover bolted on.

In order to facilitate better troubleshooting of ST9 power ends, the side covers will now include two separate inspection ports. Each port will be shaped like an oval with (8) 3/8-16 flange bolts and an o-ring. Extra components will be available to order from the ST9 warehouse. Part numbers and quantities are in the table below.
