PRODUCT:

MFR: ST9 Gas & Oil LLC

MODIFICATION:

1) Input shaft seal housing upgraded to eliminate leaking issues from pinion shaft interface.

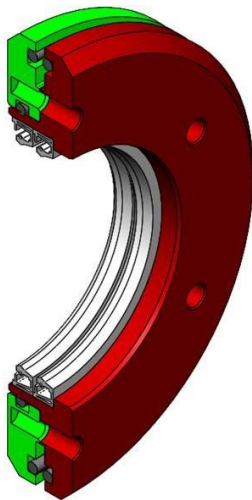
Pic 1
Housing Cutaway

DETAILS: Instead of the traditional 2 plate and gasket configuration, the new and improved housing now includes two lip seals and 3 O-rings. In field testing this has been shown to completely eliminate lube oil leaks. All part numbers are listed above.

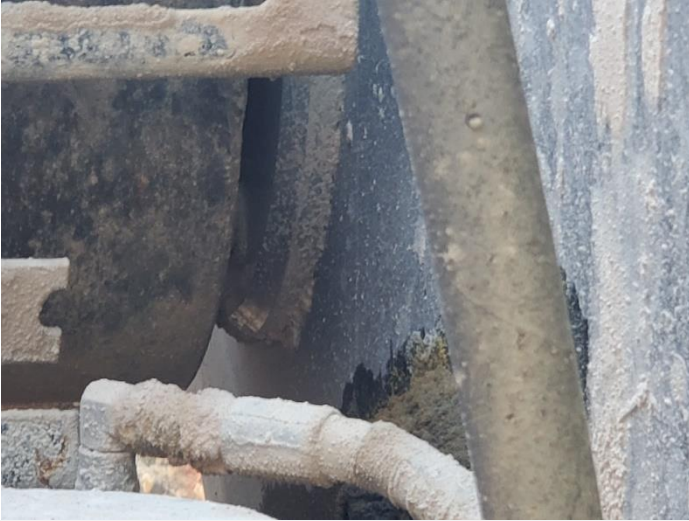
Pic 3
Housing Sits Flush

As shown in picture 3, the outer portion of the seal housing will now sit flush against the bull gear side cover instead of offset like with the gasket.
