**PRODUCT:**

- ST9 Part # 140-0004: Journal Bearing

**MFR:** ST9 Gas & Oil LLC

1) Three grooves added to the rod and cap half of the crankshaft journal bearing.

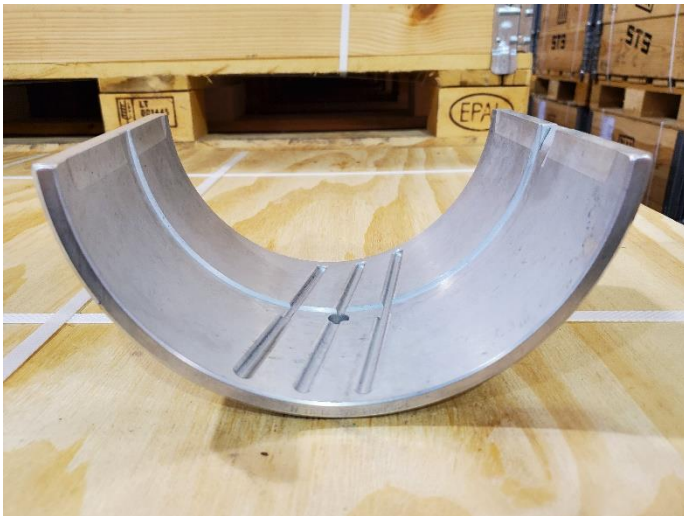
**Pic 1**  
**Journal Bearing With Grooves**

**DETAILS:** To facilitate more even lubrication across the crank journal, three oil grooves were added to the rod and cap halves of the journal bearings. Both sides have the same part number.

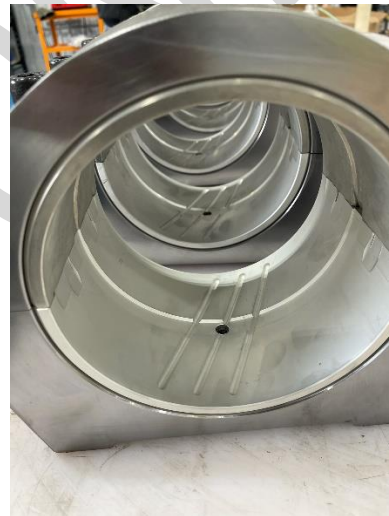
**Pic 2**  
**Journal Bearings in Knuckle**

The bearings are installed together in the knuckle for QC then broken apart and installed on the crankshaft.

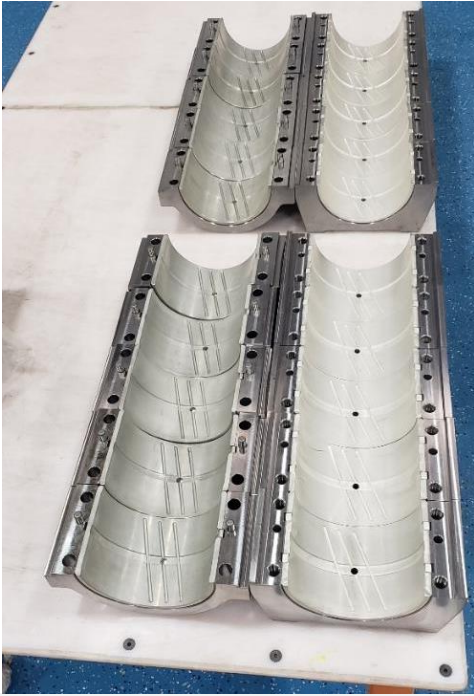
**Pic 3**  
**Broken Apart Before Crankshaft Assy**
